Bac-Pak Microbiology Influenced Corrosion Water Testing Kit
Model #BAC-PAK

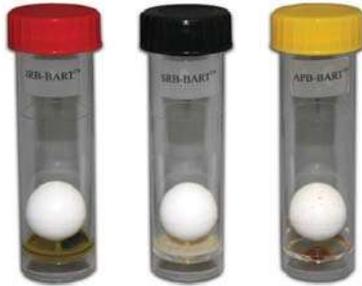
- 1 ea. "Bac-Pak" foil pack with three microbiological test vials labeled APB, SRB, and IRB.
- Vial holder
- 120cc bottle for obtaining sample
